8. Prototype l	: Busy Roadway Bus Stop				
8.1					
	Roadway				
8.2	The Selected Busy Roadway Site:				
	University Boulevard				
8.3	Busy Roadway Bus Stop				
	Recommendations

This report summarizes ACTA's Safety and Security at Suburban Bus Stops, an outgrowth of the two previous studies. The purpose of this study is to respond to existing conditions in the study area, an area built for vehicular access, to design a set of "replicable prototype bus stops and bus stop placements that address mobility and accessibility challenges faced by bus riders in an area with limited pedestrian amenities." The initial study parameters required that the Prototypes address typical suburban bus stop placements such as an intermodal hub/transfer stop, a stop along a busy roadway, a stop in an office park, and a stop within a retail mall area. Bus shelter design should incorporate technology related to real-time bus information and pedestrian amenities. The study's recommendations will also address pedestrian access to and around the bus stops so that pedestrian circulation is improved to a level of service more equal to that afforded vehicular travel.

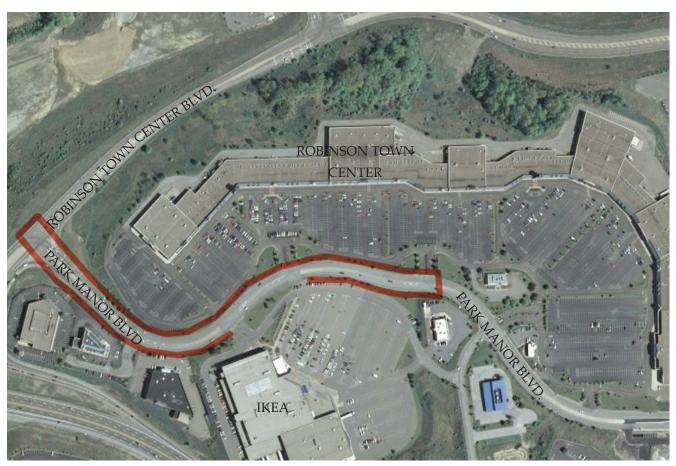
Map of Walking Tour Route

During the course of the walking tour, the accessibility experts and Stakeholders made the following observations concerning bus stop site conditions:

- Environments lacking well-defined paths may not be negotiable by the visually impaired.
- Audible crossing signals can mask traffic noise, creating a threat where there is no 'pedestrian only' signal phase.
- Drivers need to learn that the roads are shared with pedestrians and bicyclists.
- Educational opportunities to inform the public about pedestrian crossing and "white cane laws" could be developed through cooperative efforts with local businesses.
- Municipalities were encouraged to enforce compliance with ADA regulations by property owners and tenants.
- Local signage ordinances should accommodate the visually and cognitive impaired by specifying light letters on dark backgrounds.

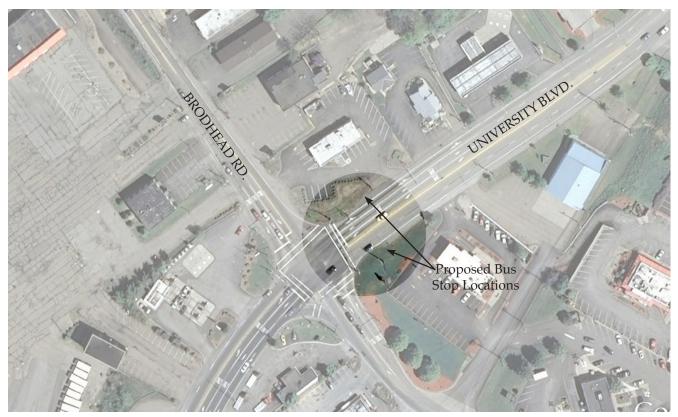
Map of Prototype I - Busy Roadway Bus Stop

Busy roadways funnel traffic through Robinson Town Centre, through The Pointe at North Fayette, and along University Boulevard in Moon Township in a manner that is challenging and frustrating for both motorists and pedestrians alike. During periods of time when traffic volumes are low, factors such as higher travel speeds, confusing access patterns, and unreadable signage combine to make way-finding difficult for motorists, while increased traffic speeds pose a danger to pedestrians forced to share the roadway due to a lack of a contiguous sidewalk systems. Conversely, when the roadways are congested and traffic is moving slowly, motorists are often more aggressive about making progress and may exercise a lesser degree of care towards pedestrians. These suburbs are typified by inadequate pedestrian pathways and crossing protections. Commercial destinations are spread out. Thus, transit riders can expect to walk significant distances to and from busy roadway bus stops in unguarded conditions.

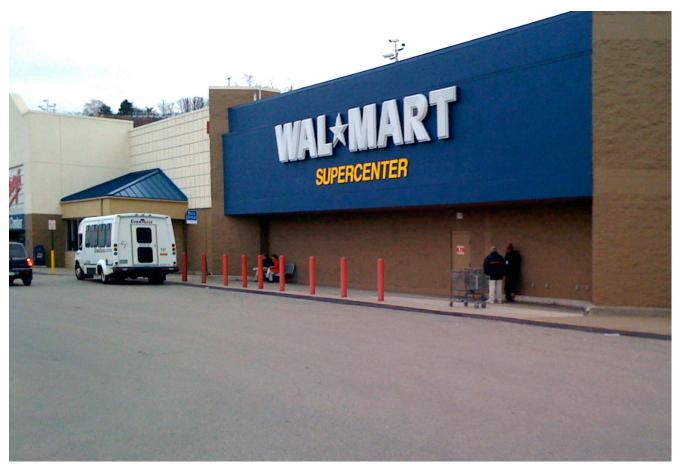
Existing Suburban Retail Bus Stop

The Walmart parking lot creates traffic movements both parallel and perpendicular to the building and the bus stop located along its face. Bus patrons are shielded from traffic by concrete-filled steel tube bollards, which are located along a depressed/flush curb that allows the easy movement of shopping carts and wheelchairs. An existing overhang, 10 feet high and no more than 6 feet deep, provides little protection from the wind or wind-driven rain and snow. Three metal benches and a cigarette urn are grouped tightly together near the bus stop sign. If multiple parties wished to sit down they would be required to gather close together within a smoking zone. Further, the benches are not spread out to allow those on motorized scooters or in wheelchairs to sit adjacent to their companions. The existing painted concrete block walls are plain and unadorned. Wind screening and bus stop lighting are lacking.

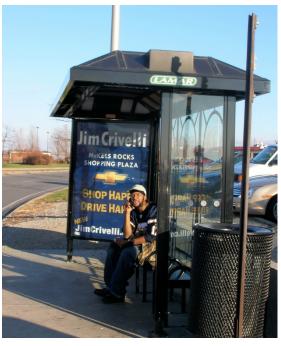
Existing Hub Station

The Bus stops flanking Park Manor Drive, near IKEA, are the hub of service for Port Authority of Allegheny County, Beaver County Transit Authority, and the local shuttle service provided by the Airport Corridor Transportation Association. The adjacent parking in the IKEA lot serves as a "park and ride." This location, however, lacks safe pedestrian crossings, does not provide shelters or street furnishings scaled to accommodate the volume of riders, and lacks bicycle facilities. The location of the stop, along a curved section of roadway beyond the existing IKEA driveway, occurs in an area where motorists would be inclined to accelerate and, consequently, poses a safety challenge.

The utilization of the existing bus stops at the Hub area, served by at minimum three transit service providers, is significant enough that the existing 2 bus stops warrant being upgraded to bus stations with larger shelters and additional patron amenities.

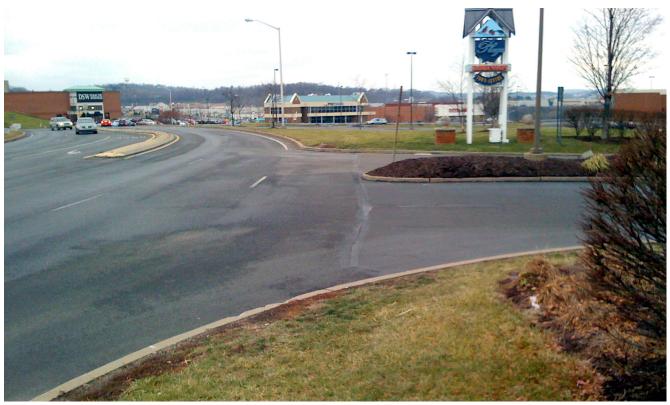
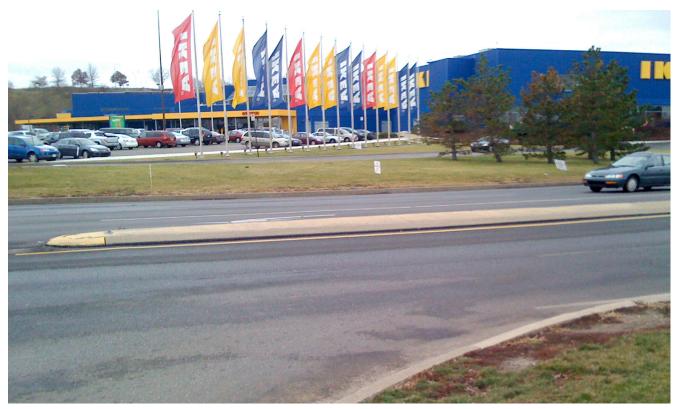
Site for the Proposed Hub Station

Finally, the design team recommends the relocation of existing stops. New near-side and far-side stations located opposite each other at the proposed reconfigured intersection accommodate a direct path between major retail centers and provide better site lines up and down Park Manor Boulevard.

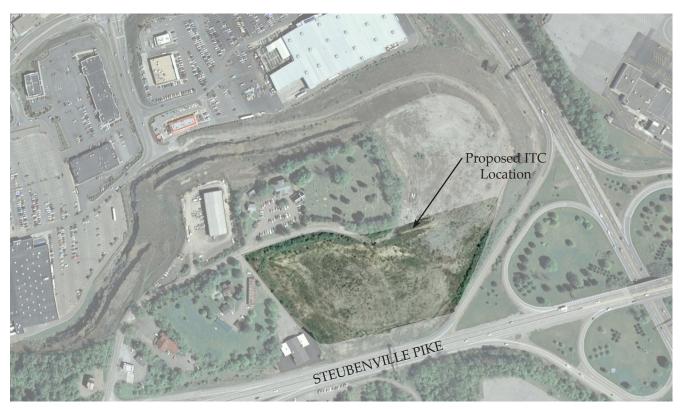
Map of Prototype IV - Intermodal Transfer Station

The planned Intermodal Transfer Center (ITC) in North Fayette Township is bounded on three sides by steep grades. Access to the site will occur along an extended Montour Church Road approached from the south along Route 22/30/Steubenville Pike or from the north along Summit Park Drive. The site is likely to be served by various transit providers including Port Authority of Allegheny County, Beaver County Transit Authority, and the Airport Corridor Transit Association's shuttle service. As such, the volume of usage at the proposed ITC will be significant enough to be classified as a bus station with larger shelters and additional patron amenities.

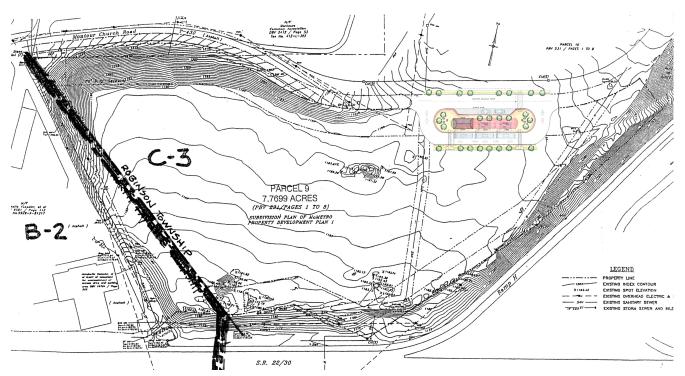
Plot Plan with Proposed Intermodal Transfer Center

- Provide a 10-foot by 20-foot shelter at each bus boarding position with clear wind screening panels to maximize visibility in and out of the shelter. Alternatively, provide continuous canopies with clear wind screening along the length of several bus docking positions.

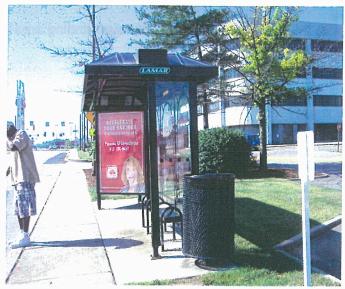
Is there a shelter? X Yes No Type of shelter? LAMAR SHELTER - Robinson Township STY/L 2. Location (street & cross streets) Park Nanor Drive & Pourte Go (Steubenville Pike) 3. Where is the stop positioned? X Nearside (before the bus crosses the intersection) Far Side (after the bus crosses the intersection) Mid-block At building entrance. What building?
Pedestrian Access Features 4. Is there a landing area adjacent to the curb/street? YesNo
Connections (Trip Generators) 8. What are the primary trip generators at the stop? Apartments S/F Housing School _X Shopping Bus Transfer X Office Building Park and Ride X Other "Unoffice!" Park 'n Riol Lot 9. Where is the nearest street crossing opportunity? Crosswalk located across from Robinson Court Entrained the result of the street of th
Pedestrian Comfort Amenities 12. Could a person using a wheelchair fit comfortably under the shelter? X YesNo 13. Could a visually impaired person identify the bus stop? X YesNo 14. Are there damages to the shelter? If so, describe. No

15	Is there seating in the shelter? X YesNo For how many? Thue (3)
Tr	ash Assessment
-	. What type of receptacle?
	X Free-standing Attached to shelter
17	Are there problems with the trash receptacle and the surrounding area?
	Trash can full
	Trash can overflowing
	Graffiti
	X Bus stop littered
	X Adjacent property littered
10	Abandoned grocery cart
	Do they create a barrier to ped traffic flow?YesX_No
	fety & Security Features

20.	Are there problems with landscaping around the bus stop?Yes _X_NoTrees/bushes encroaching the area
	Trees/bushes encroaching the sidewalk
Info	prmation Features
	Is there a bus stop sign? X Yes No
	Are bus routes indicated on the sign? X Yes No
	If yes, what routes? 28 k ; 26 E

28.	How is the sign installed?
	On its own pole
	On a building
	On a utility pole
20	On a shelter
25.	Are there problems with the sign?YesX_NoSign is in poor condition
	Sign position is hazardous to peds
	Lighting on sign is poor

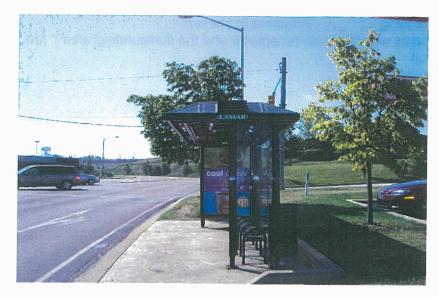
ld	entification/Location
1.	Is there a shelter? X Yes No
	Type of shelter? LAMAR SHELTEY - Poblinson Township Style Location (street & cross streets) Park Manor Blub + Robinson Lake

2.	Location (street & cross streets) Park Manor Blub + Robinson Lave
3.	Where is the stop positioned?
	Nearside (before the bus crosses the intersection)
	Far Side (after the bus crosses the intersection)
	Mid-block
	At building entrance. What building?
Pe	edestrian Access Features
	Is there a landing area adjacent to the curb/street? X Yes No
	If yes, approximately how wide? Two (2) FEET

26.	Is there a bus stop sign? X YesNo Are bus routes indicated on the sign? X YesNo
	If yes, what routes? <u>ACK', 26E', 25 D (outparen)</u> ; <u>25 C (outparen)</u> How is the sign installed? On its own pole

29.	On a building _X_On a utility poleOn a shelter Are there problems with the sign?Yes _X_No
	Sign is in poor condition Sign position is hazardous to peds Lighting on sign is poor

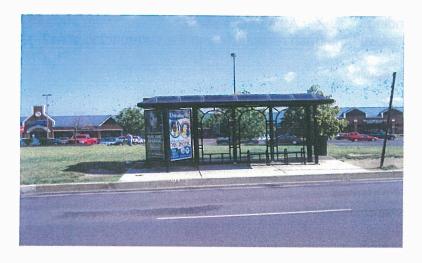
ld	entification/Location
1.	Is there a shelter? X Yes No
0	Type of shelter? LAMAR - Robinson Township Style Location (street & cross streets) Park Manor Boulevard opposite TKEA Where is the step positioned?

2.	Location (street & cross streets) Park Manor Boulevary opposite TKEA
٥.	where is the stop positioned?
	Nearside (before the bus crosses the intersection)Far Side (after the bus crosses the intersection)
	X Mid-block
	At building entrance. What building?
Pe	edestrian Access Features

24.	What type of lighting is available?
	X_Street light
	Outside light of adjacent building
	ndscaping Assessment
25.	Are there problems with landscaping around the bus stop?Yes _X_No
	Trees/bushes encroaching the area
	Trees/bushes encroaching the sidewalk
Info	ormation Features
	Is there a bus stop sign?Yes _x_No
27	Are bus routes indicated on the sign?YesNo-N/A
	If yes, what routes?

28.	How is the sign installed?- NIA
	On its own pole
	On a building
	On a utility pole
	On a shelter
29	Are there problems with the sign?-N/AYes No
<u></u>	
	Sign is in poor condition
	Sign position is hazardous to pedsLighting on sign is poor
	Lighting off sight is pool

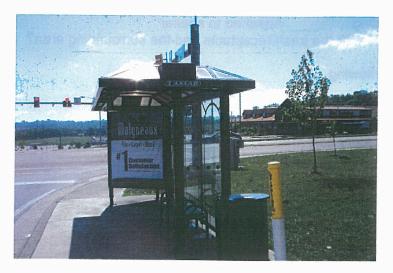
ld	entification/Location
1.	Is there a shelter? X YesNo
	Type of shelter? LAMAR - Robinson Townstip Style Location (street & cross streets) Park Manor Boulevard + Park Manor Drive

2.	Location (street & cross streets) Park Manor Boulevard + Park Manor Dive
3.	Where is the stop positioned?
	X Nearside (before the bus crosses the intersection)
	Far Side (after the bus crosses the intersection)
	Mid-block
	At building entrance. What building?
Pe	edestrian Access Features
	Is there a landing area adjacent to the curb/street? X Yes No
	If yes, approximately how wide? Two(z) Feet

15. Is there seating in the shelter? X YesNo For how many? Three
Trash Assessment 16. What type of receptacle?
Safety & Security Features 19. Where is the bus stop located? X In travel lane? Bus pull off area Paved shoulder Unpaved shoulder Off street 20. What is the posted speed limit? 25 MPH 21. What are the traffic controls at the nearest intersection? X Signal Stop/Yield Sign None Other 22. How many total lanes are on both sides of the road? Five (s) 33. Are there potential traffic hazards? X Yes No Bus stop just over crest of hill Bus stop just beyond curve in the road Waiting passengers are hidden from view of approaching bus X High speed traffic No crosswalk
Lighting Assessment 24. What type of lighting is available? Street light (MINIMA) - ONL POLE) Outside light of adjacent building Landscaping Assessment 25. Are there problems with landscaping around the bus stop? Yes No Trees/bushes encroaching the area Trees/bushes encroaching the sidewalk

Information Features 26. Is there a bus stop sign? X YesNo 27. Are bus routes indicated on the sign?YesX_No If yes, what routes? 28. How is the sign installed?
On its own poleOn a buildingX_On a utility poleOn a shelter 29. Are there problems with the sign? X_YesNoSign is in poor conditionSign position is hazardous to pedsX_Lighting on sign is poor

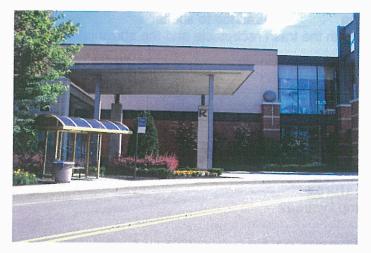
ld	lentification/Location
1.	Is there a shelter? X YesNo
_	Type of shelter? LAMAR - OLDER STYLE
2.	Location (street & cross streets) Mall at Tobinson - Entry K

3.	where is the stop positioned?
	Nearside (before the bus crosses the intersection)
	Far Side (after the bus crosses the intersection)
	Mid-block
	_x_At building entrance. What building? The Nall at Robinson
Pe	edestrian Access Features
	Is there a landing area adjacent to the curb/street? X Yes No
	If yes, approximately how wide? One (1) Foot

26. 27.	Is there a bus stop sign? X_YesNo Are bus routes indicated on the sign? X_YesNo If yes, what routes? 21 C; 25 A; 25 C (outputed); 25 D (outputed) How is the sign installed?

29.	X On its own pole On a building On a utility pole On a shelter Are there problems with the sign? Sign is in poor condition Sign position is hazardous to peds Lighting on sign is poor

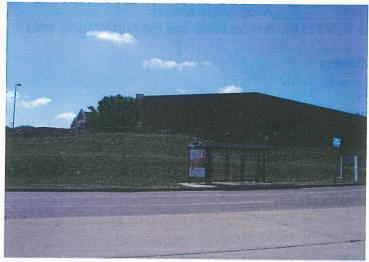
lde	ntification/Location
	s there a shelter? _X_YesNo
	Type of shelter? LAMAY - Robinson Township style
2. 1	ocation (street & cross streets) Park Manor Blup + Poblism Town Centre Blub.

3. \	Where is the stop positioned?
	X Nearside (before the bus crosses the intersection)
-	Far Side (after the bus crosses the intersection)
-	Mid-block
-	At building entrance. What building?

If yes, what routes? How is the sign installed? Y On its own pole On a building On a utility pole On a shelter
29.	Are there problems with the sign? X YesNoSign is in poor conditionSign position is hazardous to pedsLighting on sign is poor

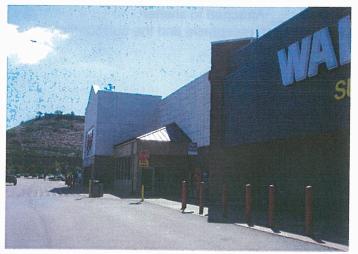
Identification/Location		
1. Is there a shelter?Yes _X_No		
Type of shelter?		
2. Location (street & cross streets) Wal-Mart Entrance		
3. Where is the stop positioned?		
Nearside (before the bus crosses the intersection)		
Far Side (after the bus crosses the intersection)		
Mid-block		
X_At building entrance. What building? Wal- Mart		
Pedestrian Access Features

4. Is there a landing area adjacent to the curb/street?Yes X No		
If yes, approximately how wide?		
5. What is the material of the landing area?		
AsphaltConcreteGrassDirtGravel

24.	What type of lighting is available?
	Street light
Lor	XOutside light of adjacent building
	Are there problems with landscaping around the hus stand.
20.	Are there problems with landscaping around the bus stop?YesX_NoTrees/bushes encroaching the area
	Trees/bushes encroaching the sidewalk
	ormation Features
	Is there a bus stop sign? Yes No

21.	Are bus routes indicated on the sign?YesNo - N/A If yes, what routes?
28	How is the sign installed? -N/A
	On its own pole
	On a building
	On a utility pole
	On a shelter
	Are there problems with the sign?-N/AYesNo
	Sign is in poor condition
	Sign position is hazardous to peds
	Lighting on sign is poor

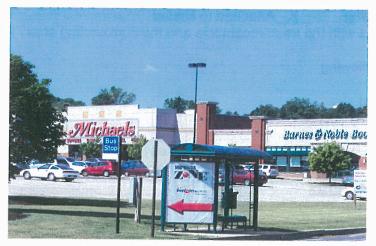
Identification/Location	
1. Is there a shelter? X Yes No	
Type of shelter? LAMAR - NORTH Fayette Style	
2. Location (street & cross streets) Summit Park Dive + Quinn Dive	-

3. Where is the stop positioned?	-
Nearside (before the bus crosses the intersection)	
Far Side (after the bus crosses the intersection)	
X Mid-block (Strip Wall Entrance)	
At building entrance. What building?	
Pedestrian Access Features

29. Are there problems with the sign? Yes No
Sign is in poor condition
Sign position is hazardous to peds
✓ Lighting on sign is poor

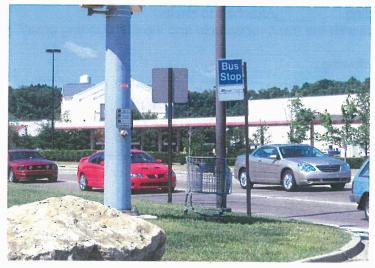
ld	entification/Location
1.	Is there a shelter?Yes _X_No
2	Type of shelter?
2.	Location (street & cross streets) Summit Park Dive Annew Dive (WAL-MART SIDE) Where is the stop positioned?
Ο.	Nearside (before the bus crosses the intersection)
	Far Side (after the bus crosses the intersection)
	Mid-block
	At building entrance. What building?
Pe	edestrian Access Features

4.	Is there a landing area adjacent to the curb/street? X Yes No
	If yes, approximately how wide? One (1) Foot
	What is the material of the landing area?
6	Asphalt Concrete Carass Dirt Gravel
Ο.	Is there a pedestrian path to/from the shelter? Yes X No
7	Is it AsphaltConcrete (sidewalk) Gravel Desire Line in the Grass Are there physical barriers at/on sidewalk?YesX_No - N/A
٠.	If yes, what are they?
Cc	nnections (Trip Generators)
	What are the primary trip generators at the stop?
	ApartmentsS/F HousingSchool _x_ShoppingBus Transfer
	Office Building Park and Ride Other

29.	Are there problems with the sign? X YesNo
	Sign is in poor condition
	Sign position is hazardous to peds
	Y Lighting on sign is poor

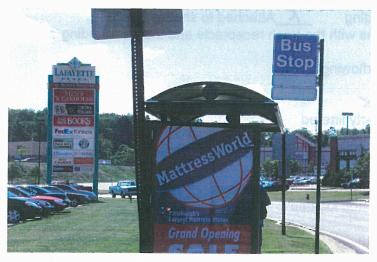
1. Is there a shelter? X YesNo Type of shelter? LAMAR - NORTH Fayette Township Style.
Type of shelter? LAMAR - North Fayette Township Style 2. Location (street & cross streets) Summit Pank Mine opposite Chavet Drive 3. Where is the stop positioned? X Nearside (before the bus crosses the intersection) Far Side (after the bus crosses the intersection) Mid-block At building entrance. What building?
Pedestrian Access Features 4. Is there a landing area adjacent to the curb/street? X YesNo If yes, approximately how wide?(z) Feet 5. What is the material of the landing area? Asphalt ConcreteX Grass Dirt Gravel 6. Is there a pedestrian path to/from the shelter? Yes No Is it Asphalt Concrete (sidewalk) Gravel Desire Line in the Grass 7. Are there physical barriers at/on sidewalk? Yes No -N/A If yes, what are they?
Connections (Trip Generators) 8. What are the primary trip generators at the stop? Apartments S/F Housing School _X_ Shopping Bus Transfer Office Building Park and Ride Other_ 9. Where is the nearest street crossing opportunity? Swall Flow Dave + Charlet Inventor Are there curb cuts at the nearest intersection? Yes No If yes, how many? Four (4) 10. Is there a companion bus stop across the street? X_ Yes No 11. Are there connections to other transportation services at this bus stop? Yes No PTI Shuttle ACTA Shuttle BCTA

Pedestrian Comfort Amenities 12. Could a person using a wheelchair fit comfortably under the shelter? YesNo 13. Could a visually impaired person identify the bus stop? YesNo 14. Are there damages to the shelter? If so, describe. No 15. Is there seating in the shelter? YesNo For how many? 2-3 peocle

25.	Are there problems with landscaping around the bus stop?YesX_No
	Trees/bushes encroaching the area
	Trees/bushes encroaching the sidewalk
Info	rmation Features
	Is there a bus stop sign? K YesNo
	Are bus routes indicated on the sign? X YesNo
	If yes, what routes? 25 A; 25 C (outraten); 28 M

28.	How is the sign installed?
	On its own pole
	On a building
	X_On a utility pole On a shelter
29	Are there problems with the sign?Yes _X No
	Sign is in poor condition
,	Sign position is hazardous to peds
	Lighting on sign is poor

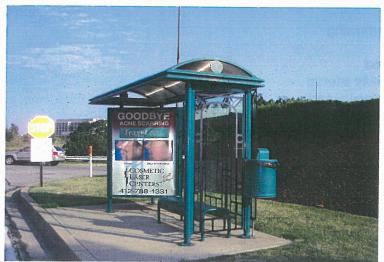
Identification/Location
1. Is there a shelter? X Yes No Type of shelter? North Fayette Township Style - LANAR 2. Location (street & cross streets) Sumul Park Office + Home Depot Service Drive 3. Where is the step positioned?
Type of shelter? North Fayette Township Style- LAMAR

2. Location (street & cross streets) Summit Park Dive + Home Denot Service Dive
3. Where is the stop positioned?
X_Nearside (before the bus crosses the intersection)
Far Side (after the bus crosses the intersection)
Mid-block
At building entrance. What building?
Pedestrian Access Features

27.	Are bus routes indicated on the sign?YesNo -N/A
	If yes, what routes?
28.	How is the sign installed? - N/A
	On its own pole
	On a building
	On a utility pole

0.0	On a shelter
29.	Are there problems with the sign? Are there problems with the sign?
	Sign is in poor condition
	Sign position is hazardous to peds
	Lighting on sign is poor

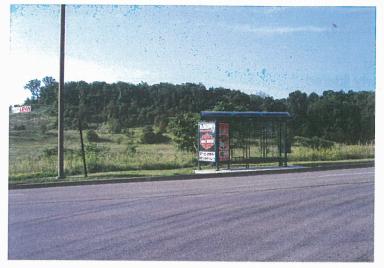
Is there a shelter?
Pedestrian Access Features 4. Is there a landing area adjacent to the curb/street?
Connections (Trip Generators) 8. What are the primary trip generators at the stop? Apartments S/F Housing School Shopping Bus Transfer X Office Building Park and Ride Other_ 9. Where is the nearest street crossing opportunity?
Pedestrian Comfort Amenities 12. Could a person using a wheelchair fit comfortably under the shelter?YesNo 13. Could a visually impaired person identify the bus stop?XYesNo 14. Are there damages to the shelter? If so, describeNo 15. Is there seating in the shelter?XYesNo For how many? 2-3No

Tra	ash Assessment
16.	What type of receptacle?
	Free-standing X Attached to shelter
17.	Are there problems with the trash receptacle and the surrounding area? No
	Trash can full
	Trash can overflowing
	Graffiti
	Bus stop littered
	Adjacent property littered
	Abandoned grocery cart

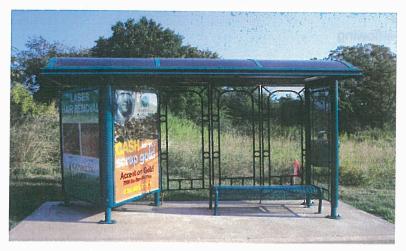
1. Is there a shelter? K Yes No Type of shelter? LAMAR - NORTH Fayette Township Style 2. Location (street & cross streets) Summit Paux Mive & Paux Lune

2. Location (street & cross streets) Summit Track Dave a Park Land 3. Where is the stop positioned?
Pedestrian Access Features 4. Is there a landing area adjacent to the curb/street? _X_YesNo If yes, approximately how wide? _Two (z) Feet 5. What is the material of the landing area?AsphaltX_ConcreteGrassDirtGravel 6. Is there a pedestrian path to/from the shelter? _X_YesNo Is itAsphaltConcrete (sidewalk)Gravel _x_Desire Line in the Grass 7. Are there physical barriers at/on sidewalk?YesNoN/A- If yes, what are they?
Connections (Trip Generators) 8. What are the primary trip generators at the stop? Apartments S/F Housing School Shopping Bus TransferX Office Building Park and Ride Other 9. Where is the nearest street crossing opportunity? Summer Trank Delive + Park Lane Are there curb cuts at the nearest intersection? YesX No If yes, how many? 10. Is there a companion bus stop across the street? X Yes No 11. Are there connections to other transportation services at this bus stop? Yes X No PTI Shuttle ACTA Shuttle BCTA

Pedestrian Comfort Amenities 12. Could a person using a wheelchair fit comfortably under the shelter? Yes X No 13. Could a visually impaired person identify the bus stop? Yes No 14. Are there damages to the shelter? If so, describe. No 15. Is there seating in the shelter? Yes No For how many? 2-3 people.

20.	What is the posted speed limit? 35 MPH
	What are the traffic controls at the nearest intersection?
	Signal X Stop/Yield Sign None Other
22.	How many total lanes are on both sides of the road? Four (4)
	Are there potential traffic hazards? X Yes No
	Bus stop just over crest of hill
	Bus stop just beyond curve in the road
	Waiting passengers are hidden from view of approaching bus
	<u>⊀</u> High speed traffic
	<u>⊁</u> No crosswalk
	hting Assessment

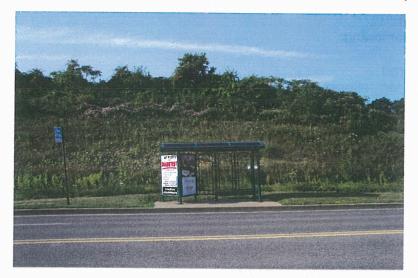
Is there a shelter? X Yes No Type of shelter? LAMAK - North Fayetle Township Style Location (street & cross streets) Summit Park Mive opposite TNC Data Center
Pedestrian Access Features 4. Is there a landing area adjacent to the curb/street? YesNo
Connections (Trip Generators) 8. What are the primary trip generators at the stop? Apartments S/F Housing School Shopping Bus TransferX
Pedestrian Comfort Amenities 12. Could a person using a wheelchair fit comfortably under the shelter?YesX_No 13. Could a visually impaired person identify the bus stop?X_YesNo 14. Are there damages to the shelter? If so, describeNo 15. Is there seating in the shelter?X_YesNo For how many? 2-3 Deeple

Ira	asn Assessment
16	What type of receptacle?
	Free-standing X Attached to shelter
17.	Are there problems with the trash receptacle and the surrounding area? 🖊 🗸
	Trash can full
	Trash can overflowing
	Graffiti
	Bus stop littered
	Adjacent property littered
	Abandoned grocery cart

20.	What is the posted speed limit? 35 MPH
	What are the traffic controls at the nearest intersection?
	SignalStop/Yield Sign x NoneOther
22.	How many total lanes are on both sides of the road? Four (4)
	Are there potential traffic hazards? X Yes No
	Bus stop just over crest of hill
	Bus stop just beyond curve in the road
	Waiting passengers are hidden from view of approaching bus
	K High speed traffic
	メ No crosswalk
Lia	hting Assessment
	What type of lighting is available?
	X Street light
	Outside light of adjacent building
Lai	ndscaping Assessment
	Are there problems with landscaping around the bus stop?Yes _X_No

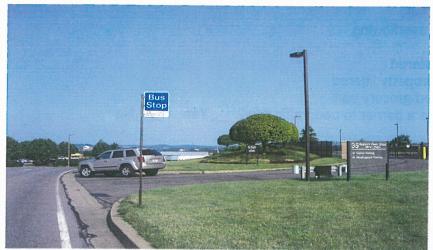
1. Is there a shelter?YesX_No Type of shelter? 2. Location (street & cross streets) Summit Park Mive + PNC Data Central Entrance 3. Where is the stop positioned?Nearside (before the bus crosses the intersection)Far Side (after the bus crosses the intersection)X_Mid-block
Pedestrian Access Features 4. Is there a landing area adjacent to the curb/street? X YesNo If yes, approximately how wide? Two (2) Feet 5. What is the material of the landing area? Asphalt Concrete _X Grass Dirt Gravel 6. Is there a pedestrian path to/from the shelter? Yes No Is it Asphalt Concrete (sidewalk) Gravel Desire Line in the Grass 7. Are there physical barriers at/on sidewalk? Yes No - N/A If yes, what are they?
Connections (Trip Generators) 8. What are the primary trip generators at the stop? Apartments S/F Housing School Shopping Bus TransferX_ Office Building Park and Ride Other_ 9. Where is the nearest street crossing opportunity? Summet Track before 4 Track Lake Are there curb cuts at the nearest intersection? YesX_ No If yes, how many? 10. Is there a companion bus stop across the street? X Yes No 11. Are there connections to other transportation services at this bus stop? Yes No PTI Shuttle ACTA Shuttle BCTA

Pedestrian Comfort Amenities 12. Could a person using a wheelchair fit comfortably under the shelter?YesNo - No Shelter 13. Could a visually impaired person identify the bus stop?YesNo 14. Are there damages to the shelter? If so, describe. N A 15. Is there seating in the shelter?YesNo - N A For how many?

23.	Are there potential traffic hazards? X YesNo
	Bus stop just over crest of hill
	Bus stop just beyond curve in the road
	Waiting passengers are hidden from view of approaching bus
	High speed traffic
	NO GIOSSWAIK
Lia	hting Assessment
	What type of lighting is available?
	K Street light
	X Outside light of adjacent building
Lar	ndscaping Assessment
	Are there problems with landscaping around the bus stop? Yes X No
	Trees/bushes encroaching the area
	Trees/bushes encroaching the sidewalk
	ormation Features
	Is there a bus stop sign? X Yes No

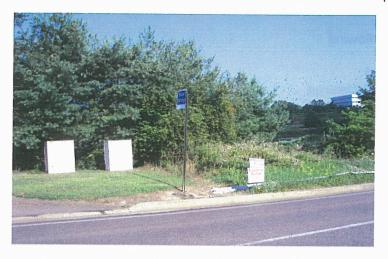
Identification/Location 1. Is there a shelter?YesX_No Type of shelter?
2. Location (street & cross streets) Summit Park Drive opposite Park Lane (Mainstry Suites \$10 3. Where is the stop positioned? Nearside (before the bus crosses the intersection) Far Side (after the bus crosses the intersection) X Mid-block At building entrance. What building?
Pedestrian Access Features 4. Is there a landing area adjacent to the curb/street? X YesNo If yes, approximately how wide? (I) Foot 5. What is the material of the landing area? Asphalt Concrete Grass _X _Dirt Gravel 6. Is there a pedestrian path to/from the shelter? Yes _X _No Is it Asphalt Concrete (sidewalk) Gravel Desire Line in the Grass 7. Are there physical barriers at/on sidewalk? Yes No - N/A If yes, what are they?
Connections (Trip Generators) 8. What are the primary trip generators at the stop? Apartments S/F Housing School Shopping Bus TransferX_ Office Building Park and Ride Other_ 9. Where is the nearest street crossing opportunity? Summt Park Dalk Lake Are there curb cuts at the nearest intersection? Yes No If yes, how many? 10. Is there a companion bus stop across the street? X_Yes No 11. Are there connections to other transportation services at this bus stop? Yes No PTI Shuttle ACTA Shuttle BCTA

Pedestrian Comfort Amenities 12. Could a person using a wheelchair fit comfortably under the shelter?YesNo - N/A 13. Could a visually impaired person identify the bus stop?YesX No 14. Are there damages to the shelter? If so, describeN/A 15. Is there seating in the shelter?YesNo - N/A For how many?

21.	Signal Stop/Yield Sign None Other
22	How many total lanes are on both sides of the road? Four (1)
	Are there potential traffic hazards? X Yes No
20.	Bus stop just over crest of hill
	Bus stop just beyond curve in the road
	Waiting passengers are hidden from view of approaching bus
	High speed traffic
	× No crosswalk
Lion	hatina Annanana
1000	hting Assessment

28.	How is the sign installed?
	X_On its own pole
	On a building
	On a utility pole
	On a shelter
29.	Are there problems with the sign? XYesNo
	Sign is in poor condition
	Sign position is hazardous to peds
	X_Lighting on sign is poor

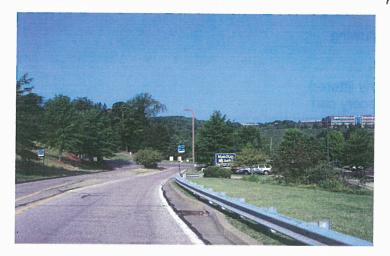
lder	ntification/Location
1. Is	sthere a shelter? Yes X No
	Type of shelter?
2. L	ocation (street & cross streets) Park Lane opposite Main Stay Suites
3. W	where is the stop positioned:
	Nearside (before the bus crosses the intersection)
	Far Side (after the bus crosses the intersection)
	<u>X_</u> Mid-block
_	At building entrance. What building?
Ped	estrian Access Features

4. Is	there a landing area adjacent to the curb/street? X Yes No
lf	yes, approximately how wide? Two (2) Feet
5. W	/hat is the material of the landing area?
	AsphaltConcrete <u>X</u> GrassDirtGravel

23.	Are there potential traffic hazards? X YesNo
	Bus stop just over crest of hill
	Bus stop just beyond curve in the road
	Waiting passengers are hidden from view of approaching bus
	High speed traffic ★ No crosswalk
	NO Closswalk
Lia	hting Assessment
	What type of lighting is available?

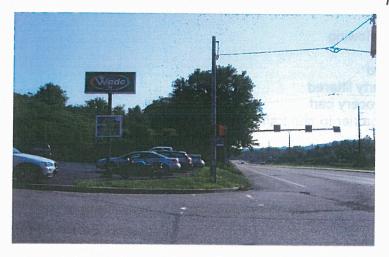
Identification/Location
1. Is there a shelter? Yes X No
Type of shelter?
2. Location (street & cross streets) Market Place Blvo. & Montaur Run Road
3. Where is the stop positioned?
_X_Nearside (before the bus crosses the intersection)Far Side (after the bus crosses the intersection)
Mid-block
At building entrance. What building?
Pedestrian Access Features

4. Is there a landing area adjacent to the curb/street? X Yes No
If yes, approximately how wide? One (1) Foot
5. What is the material of the landing area?
AsphaltConcreteGrassDirtGravel

13. Could a visually impaired person identify the bus stop? Yes 🗶 No
14. Are there damages to the shelter? If so, describe. NA
15. Is there seating in the shelter?YesNoNA For how many?
· · · · · · · · · · · · · · · · · · ·

23.	Are there potential traffic hazards?No
	Bus stop just over crest of hill
	Bus stop just beyond curve in the road Waiting passangers are hidden from view of approaching hus
	Waiting passengers are hidden from view of approaching bus High speed traffic
	× No crosswalk
	. To di obolitani
Lig	hting Assessment
	What type of lighting is available?
	Street light
	X Outside light of adjacent building
Lar	ndscaping Assessment

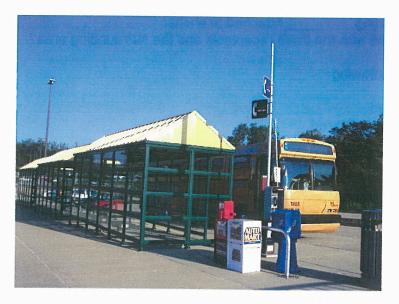
Identification/Location
1. Is there a shelter? X Yes No
Type of shelter? Port Authority - Park and Rise Style (3 Shelters)
2. Location (street & cross streets) University Boulevard Park and Ride (University Blvp + Portva 3. Where is the stop positioned? In the Park and Place LOT
Nearside (before the bus crosses the intersection)
Far Side (after the bus crosses the intersection)
Mid-block
At building entrance. What building?
Pedestrian Access Features

4. Is there a landing area adjacent to the curb/street? X Yes No
If yes, approximately how wide? Three (3) Feet
5. What is the material of the landing area?
AsphaltX_ConcreteGrassDirtGravel

12. Could a person using a wheelchair fit comfortably under the shelter? X Yes No
13. Could a visually impaired person identify the bus stop? X Yes No
14. Are there damages to the shelter? If so, describe. No

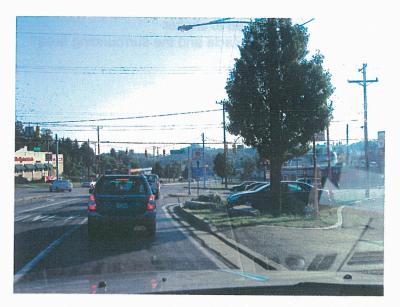
<u>Identification/Location</u>	
1. Is there a shelter? Yes X No	
Type of shelter?	
2. Location (street & cross streets) University Blub. + Bear	ver Grade Road

3. Where is the stop positioned?	
Nearside (before the bus crosses the intersection)	
Far Side (after the bus crosses the intersection)	
Mid-block	
At building entrance. What building?	
Pedestrian Access Features

23. Are there potential traffic hazards? X YesNo
Bus stop just over crest of hill
Bus stop just beyond curve in the road
Waiting passengers are hidden from view of approaching bus
_X_High speed traffic No crosswalk
IVO CIOSSWAIK
Lighting Assessment

29. Are there problems with the sign? X YesNo
Sign is in poor condition
X Sign position is hazardous to peds
Lighting on sign is poor

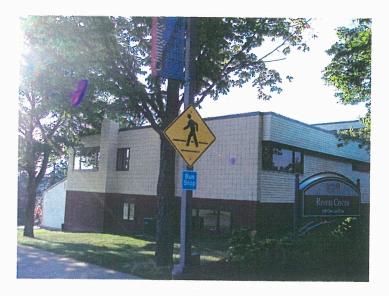
entification/Location Is there a shelter?YesX_No
2. 3.	Type of shelter? Location (street & cross streets) University Blvb. + Campus Mive (RMU - Inhound) Where is the stop positioned? —Nearside (before the bus crosses the intersection) —Far Side (after the bus crosses the intersection) X Mid-block —At building entrance. What building?
Pe	edestrian Access Features
	Is there a landing area adjacent to the curb/street? X Yes No
5	If yes, approximately how wide? Two (2) Fact What is the material of the landing area?

J.	AsphaltX_ConcreteGrassDirtGravel
6.	io there a pedestrian path tomorn the sheller (168 M)
	Is it Asphalt X Concrete (sidewalk) Gravel Desire Line in the Grass

21.	What are the traffic controls at the nearest intersection?
22	X Signal Stop/Yield Sign None Other
	How many total lanes are on both sides of the road? Two (>) Are there potential traffic hazards?Yes No

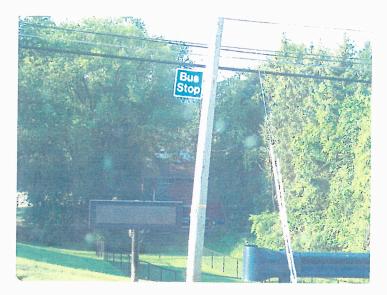
ld	entification/Location
1.	Is there a shelter? Yes X No
2.	Location (street & cross streets) Campus Dive + Pennsylvania Que. (RMU - JuBaura)
3 .	vynere is the stop positioned?
	X Nearside (before the bus crosses the intersection)
	Far Side (after the bus crosses the intersection)
	Mid-block
	At building entrance. What building?
Pe	edestrian Access Features

4.	Is there a landing area adjacent to the curb/street? X YesNo
	If yes, approximately how wide? Two (2) Feet
5.	What is the material of the landing area?
	Asphalt Concrete X Grass Dirt Gravel
Ό.	is there a pedestrian path to/from the shelter? X Yes No
	Is it AsphaltX Concrete (sidewalk) Gravel Desire Line in the Grass

20.	Off street What is the posted speed limit? 25 MPH
21.	What are the traffic controls at the nearest intersection?
	Signal X Stop/Yield Sign None Other How many total lanes are on both sides of the road? Two (2) Are there potential traffic hazards? Yes X No Bus stop just over crest of hill Bus stop just beyond curve in the road Waiting passengers are hidden from view of approaching bus High speed traffic No crosswalk
	hting Assessment What type of lighting is available?
	X Street light
Lar	Outside light of adjacent building Idscaping Assessment
	Are there problems with landscaping around the bus stop?Yes _X_NoTrees/bushes encroaching the areaTrees/bushes encroaching the sidewalk
	ormation Features
	Is there a bus stop sign? X YesNo Are bus routes indicated on the sign?YesX No

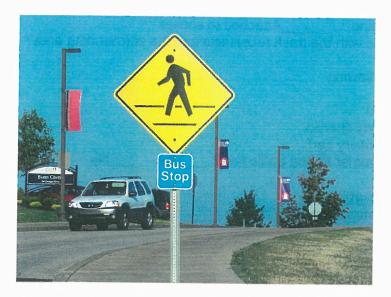
<u>Identification/Location</u>
1. Is there a shelter? Yes X No
Type of shelter?
2. Location (street & cross streets) Wassey Drive + Campus Drive
3. Where is the stop positioned?
Nearside (before the bus crosses the intersection)
Far Side (after the bus crosses the intersection)
_X_Mid-block
At building entrance. What building?
Dedoctrion Access Factures
Pedestrian Access Features

4. Is there a landing area adjacent to the curb/street? X YesNo
If yes, approximately how wide? Two(2) Fee+ 5. What is the material of the landing area?
Asphalt
AsphaltX_ConcreteGrassDirtGravel 6. Is there a pedestrian path to/from the shelter?XYesNo
Is it Asphalt _X_Concrete (sidewalk) Gravel Desire Line in the Grass

23. Are there potential traffic hazards?Yes _X_No
Bus stop just over crest of hill
Bus stop just beyond curve in the road
Waiting passengers are hidden from view of approaching bus
High speed traffic
No crosswalk
Lighting Assessment

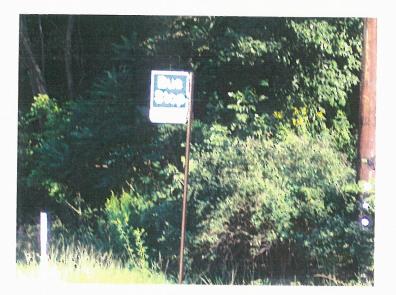
Id	entification/Location
1.	Is there a shelter?Yes _X_No
2	Type of shelter?
3	Location (street & cross streets) University Blub. 4 Stoops Ferry Where is the stop positioned?
Ο.	Nearside (before the bus crosses the intersection)
	∠ Far Side (after the bus crosses the intersection)
	Mid-block
	At building entrance. What building?
Pe	edestrian Access Features
	Is there a landing area adjacent to the curb/street? X Yes No.
	If yes, approximately how wide? Two (=) Feet

5.	What is the material of the landing area?
0	AsphaltConcreteX_GrassDirtGravel Is there a pedestrian path to/from the shelter?YesX_No
Ο.	Is there a pedestrian path to/from the shelter? Yes X No
7	Is it Asphalt Concrete (sidewalk) Gravel Desire Line in the Grass
١.	Are there physical barriers at/on sidewalk?YesNo If yes, what are they?
	you, what are they:
Co	onnections (Trip Generators)
	What are the primary trip generators at the stop?
	Apartments S/F Housing School V Shapping Bus Transfer
	Office BuildingPark and RideOtherWhere is the nearest street crossing opportunity? University Blue + Straps Ferry

23.	Are there potential traffic hazards? X YesNoBus stop just over crest of hillBus stop just beyond curve in the roadWaiting passengers are hidden from view of approaching bus _X High speed trafficNo crosswalk
	hting Assessment What type of lighting is available?
	X Street light Outside light of adjacent building
	ndscaping Assessment Are there problems with landscaping around the bus stop?

20.	X Trees/bushes encroaching the area Trees/bushes encroaching the sidewalk
-	ormation Features
	Is there a bus stop sign? X YesNo Are bus routes indicated on the sign? X YesNo

28.	If yes, what routes? 2 C How is the sign installed?
	On its own poleOn a buildingOn a utility pole
29.	On a shelter Are there problems with the sign? X YesNoSign is in poor condition X Sign position is hazardous to pedsLighting on sign is poor

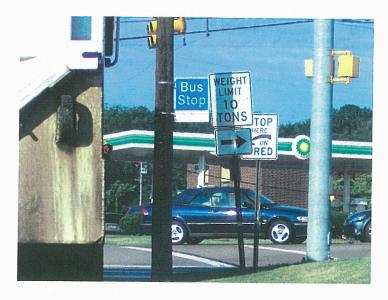
Identification/Location
1. Is there a shelter?Yes _X_No Type of shelter?
2. Location (street & cross streets) University Blub Brodhead Road
3. Wriere is the stop positioned?
_X_Nearside (before the bus crosses the intersection)
Far Side (after the bus crosses the intersection)Mid-block
At building entrance. What building?
Pedestrian Access Features

4. Is there a landing area adjacent to the curb/street? X Yes No
If yes, approximately how wide? Two (z) Feet
5. What is the material of the landing area?
AsphaltConcrete _X_ GrassDirtGravel 6. Is there a pedestrian path to/from the shelter?Yes _X_No
Is it Asphalt Concrete (sidewalk) Gravel Desire Line in the Grass

21.	What are the traffic controls at the nearest intersection?
00	SignalStop/Yield SignNoneOther
	How many total lanes are on both sides of the road?
23.	Are there potential traffic hazards? X YesNo
	Bus stop just over crest of hill
	Bus stop just beyond curve in the road
	Waiting passengers are hidden from view of approaching busX High speed traffic
	No crosswalk
	IVO GIOSSWAIIX
Liq	hting Assessment
	What type of lighting is available?
	X Street light
	Outside light of adjacent building
Lan	dscaping Assessment

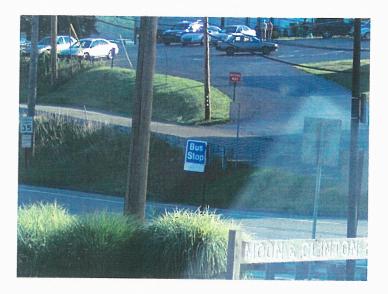
ld	entification/Location
1.	Is there a shelter? Yes X No
2	Type of shelter?
2.	Location (street & cross streets) University Blub. + Moon Clinton Ro.
٥.	Where is the stop positioned?
	_X_Nearside (before the bus crosses the intersection)Far Side (after the bus crosses the intersection)
	Mid-block
	At building entrance. What building?
Pe	edestrian Access Features
	Is there a landing area adjacent to the curb/street? X Yes No
	If yes, approximately how wide? Two (2) Fee +

5.	What is the material of the landing area?
	AsphaltConcrete X_ GrassDirtGravel Is there a pedestrian path to/from the shelter?YesXNo
6.	Is there a pedestrian path to/from the shelter? Yes X No
	Is it AsphaltConcrete (sidewalk)GravelDesire Line in the Grass

13. 11	Could a visually impaired person identify the bus stop? Yes X No
14.	Are there damages to the shelter? If so, describe.
